BRIDGE CONDITION REPORT

ROUTE: FAP 627 (IL 71)

EXIST. S.N.: 050-0030

**LOCATION: ILLINOIS ROUTE 71
OVER STREAM**

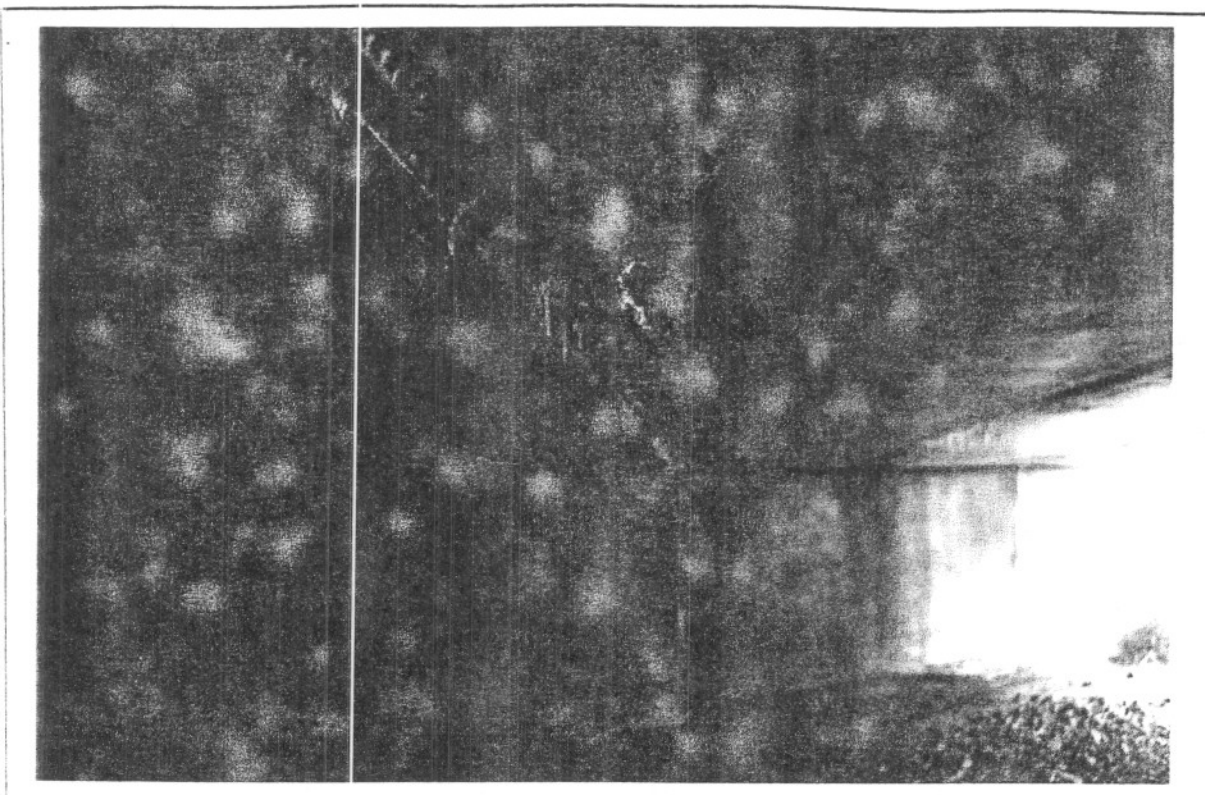
Photo # 3

Spalled Area in East Span Between Beams 3 & 4

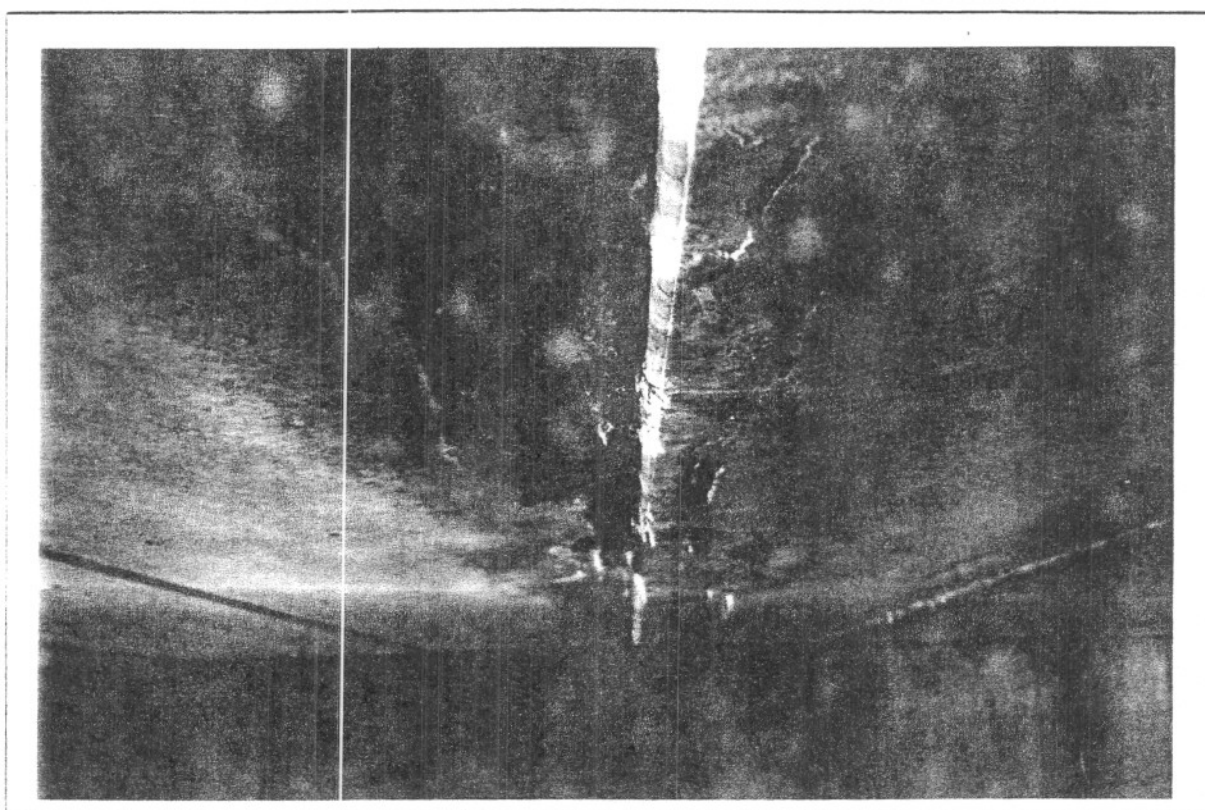
Photo # 4

Spalled Area in East Span Between Beams 6 & 7

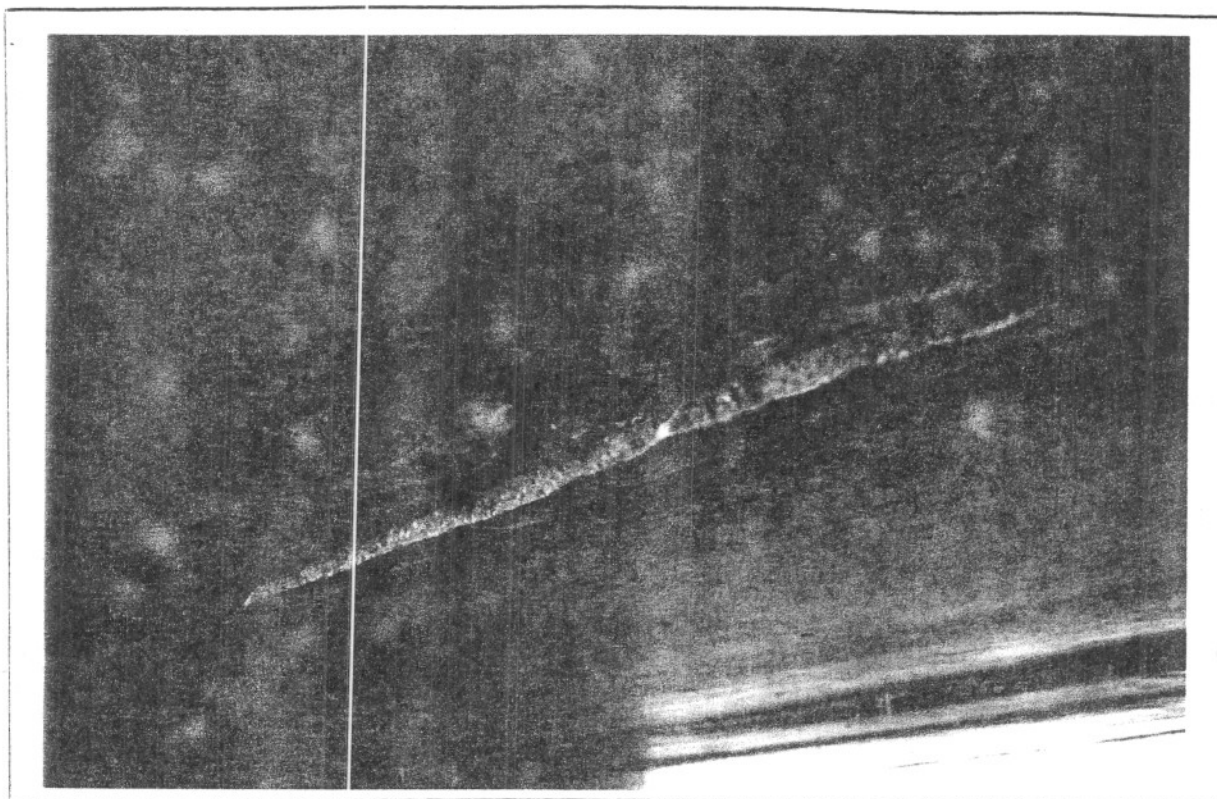
Photo # 5*Spalled Area in East Span on Beam 4*

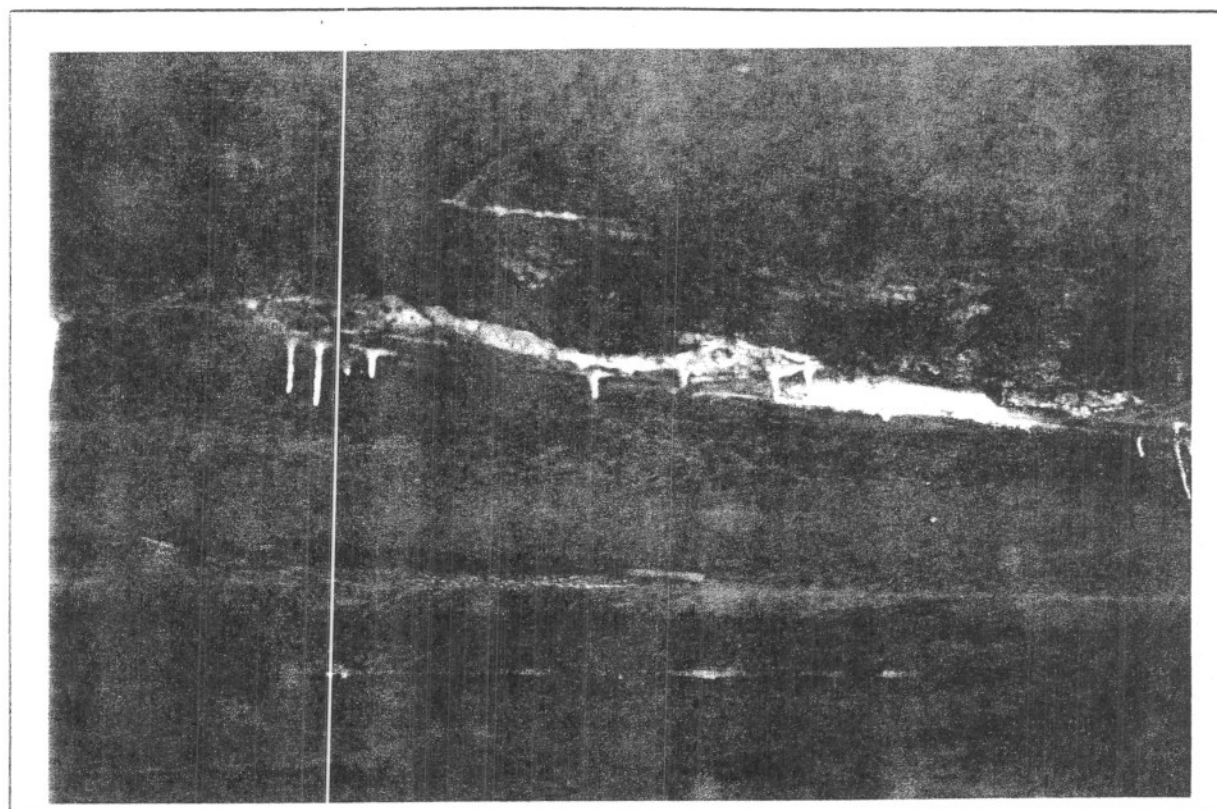
Photo # 6*Spalled Area in West Span on Beam 3*

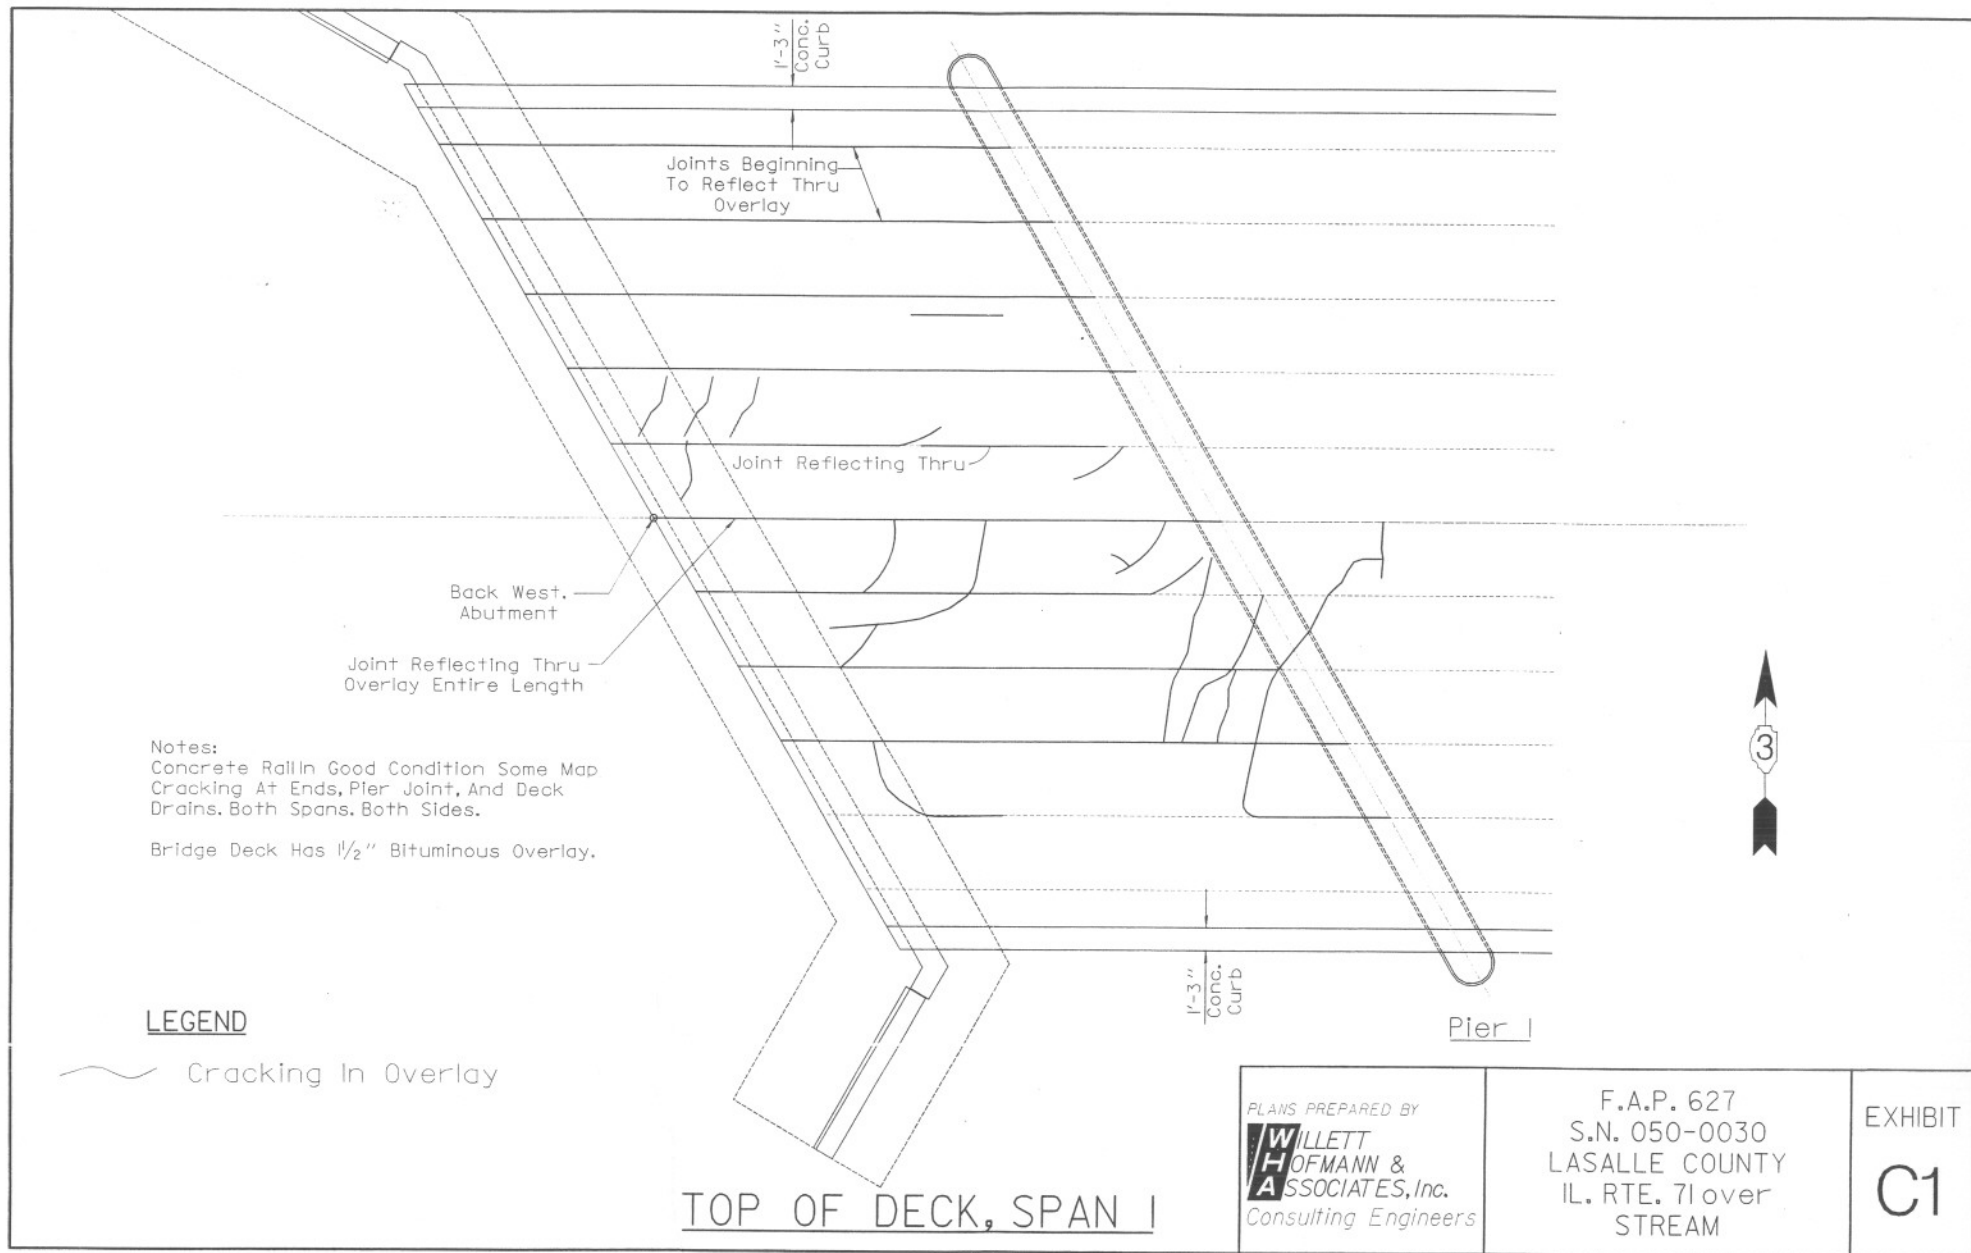
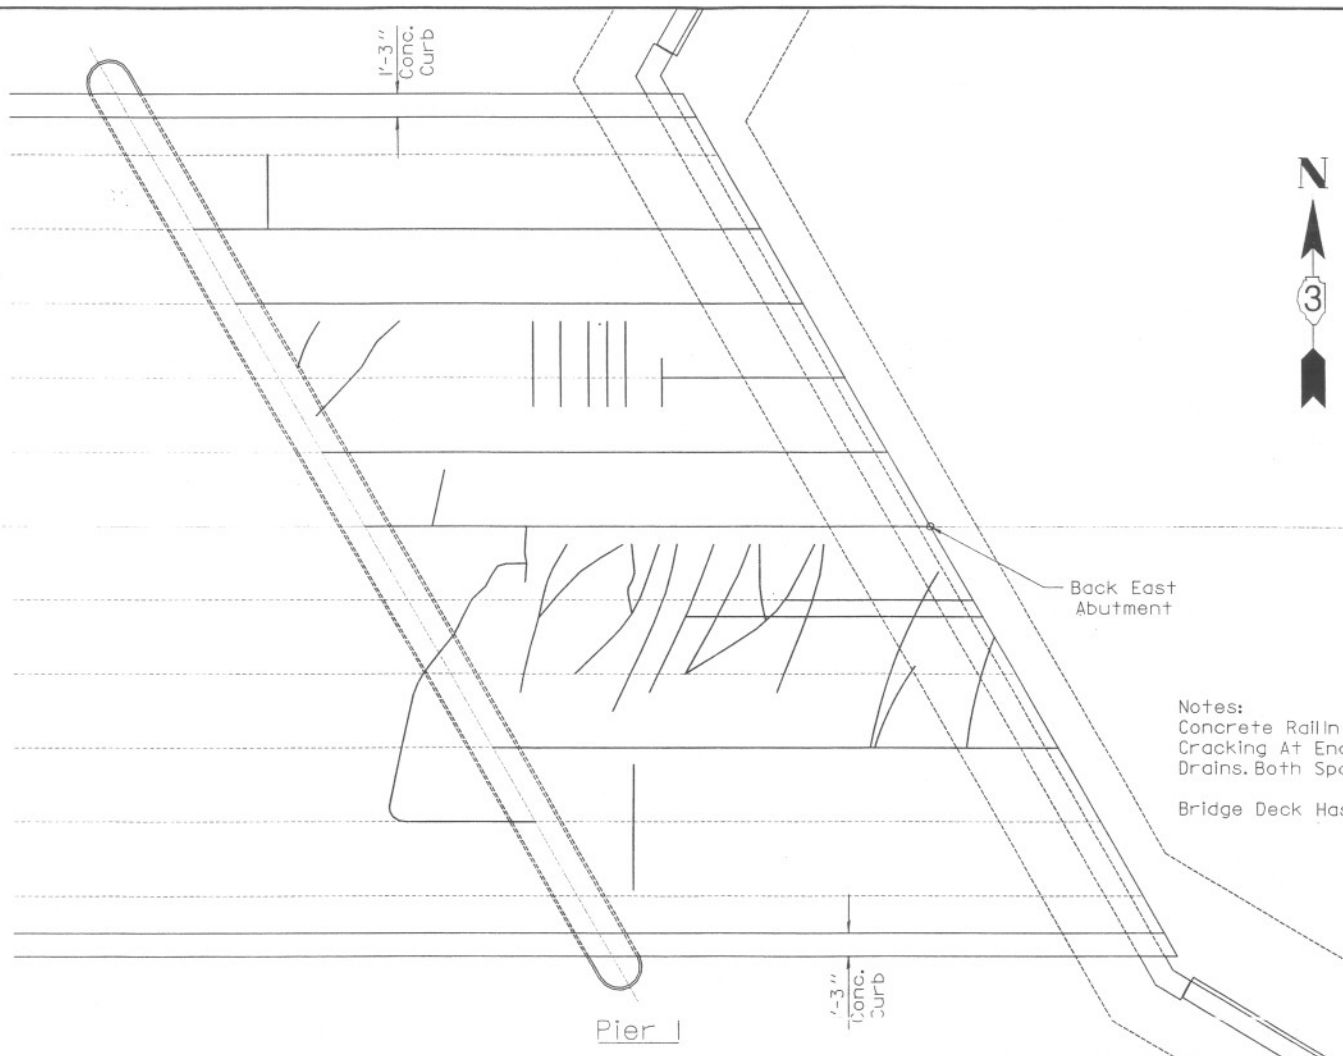
Notes:
 Concrete Rallin Good Condition Some Map
 Cracking At Ends, Pier Joint, And Deck
 Drains, Both Spans, Both Sides.
 Bridge Deck Has 1 1/2" Bituminous Overlay.

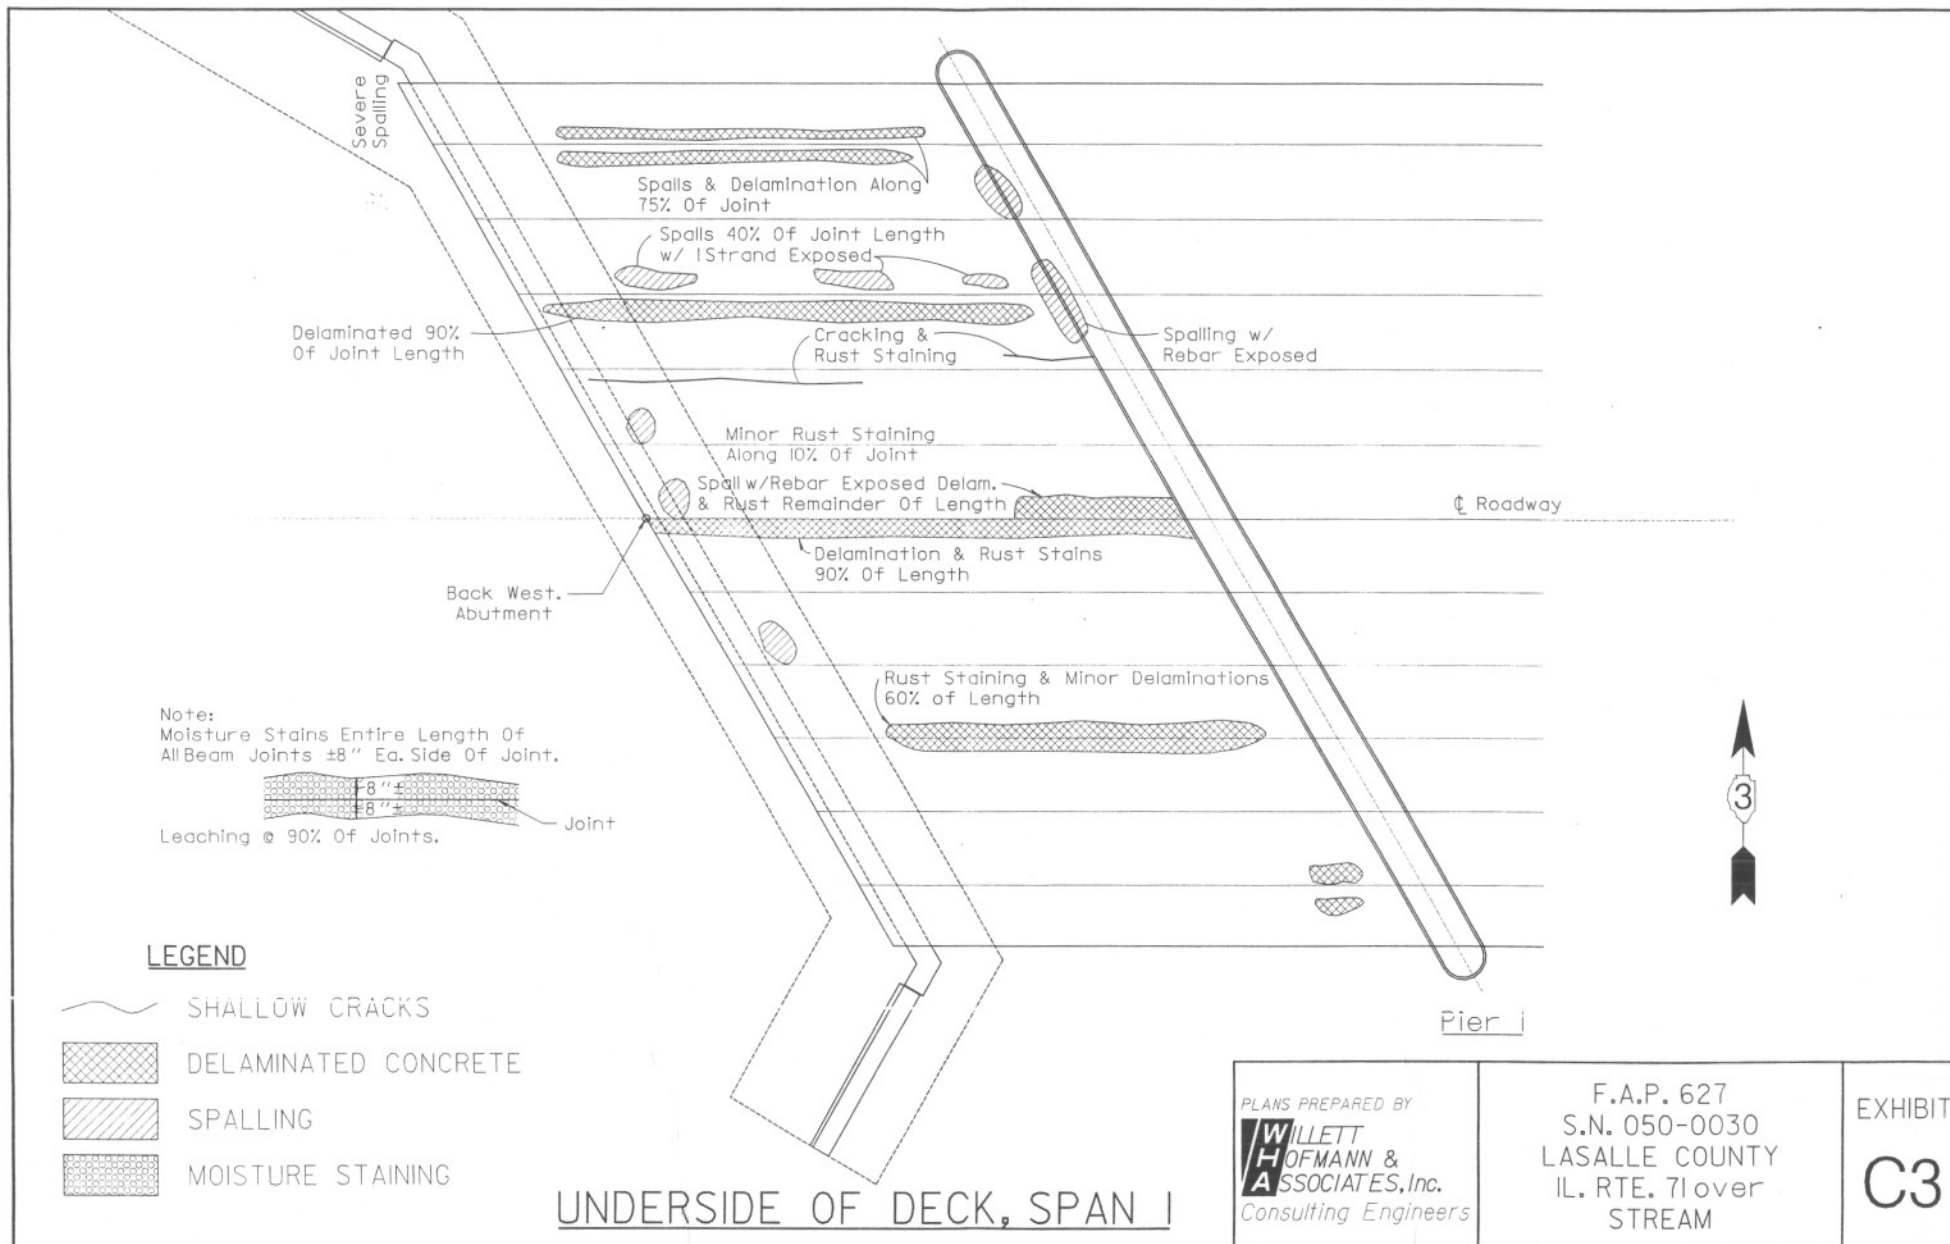
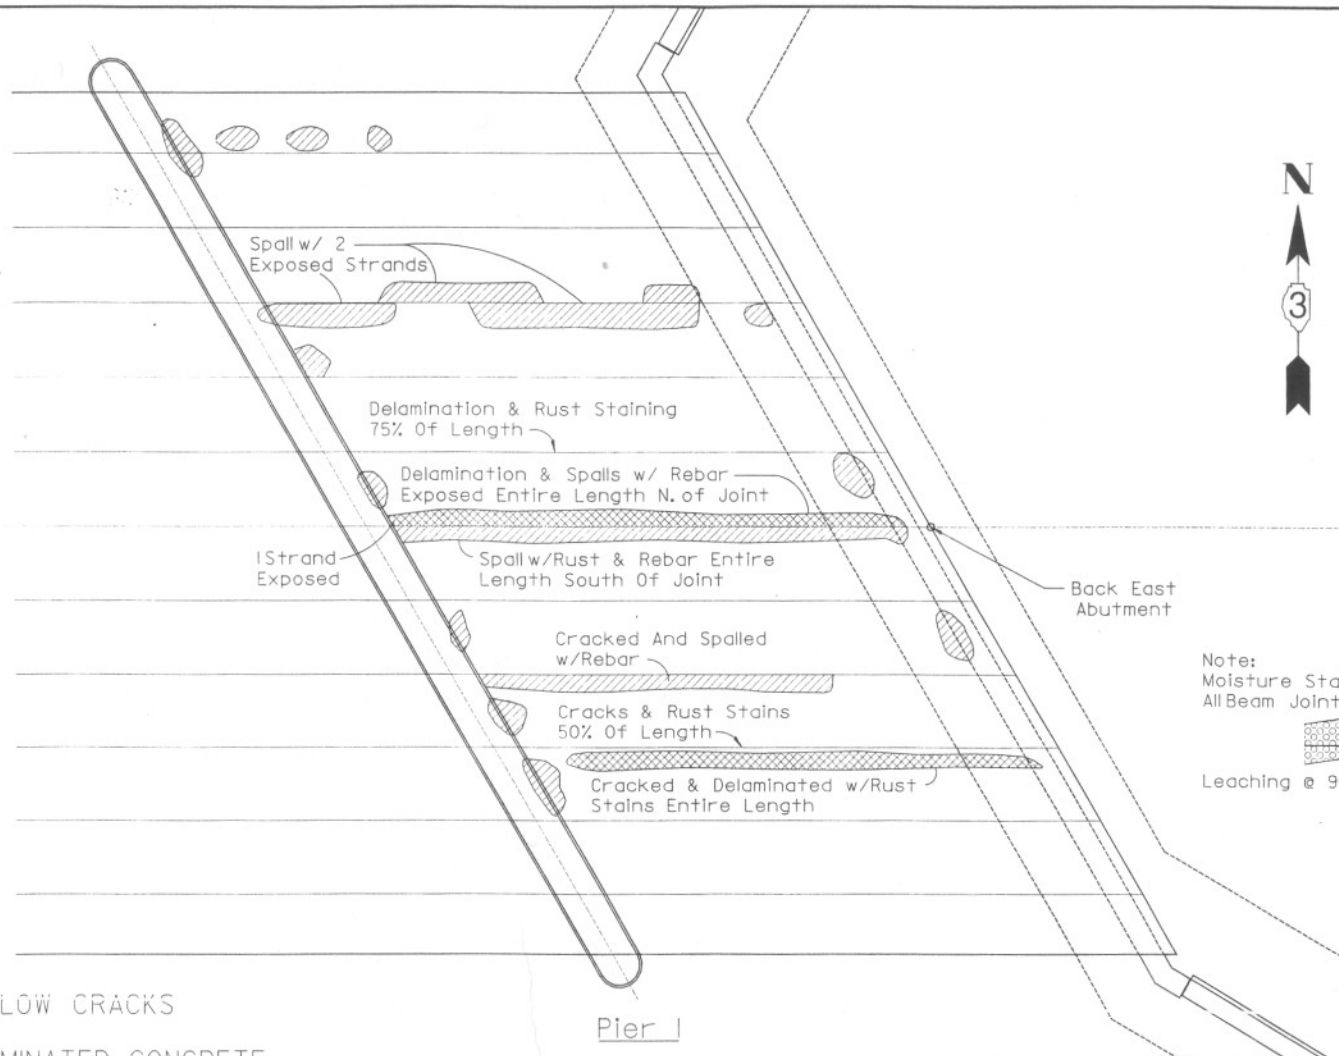
EXHIBIT  
**C2**

Note:  
Moisture Stains Entire Length Of  
All Beam Joints  $\pm 8"$  Ea. Side Of Joint.

Leaching @ 90% Of Joints.

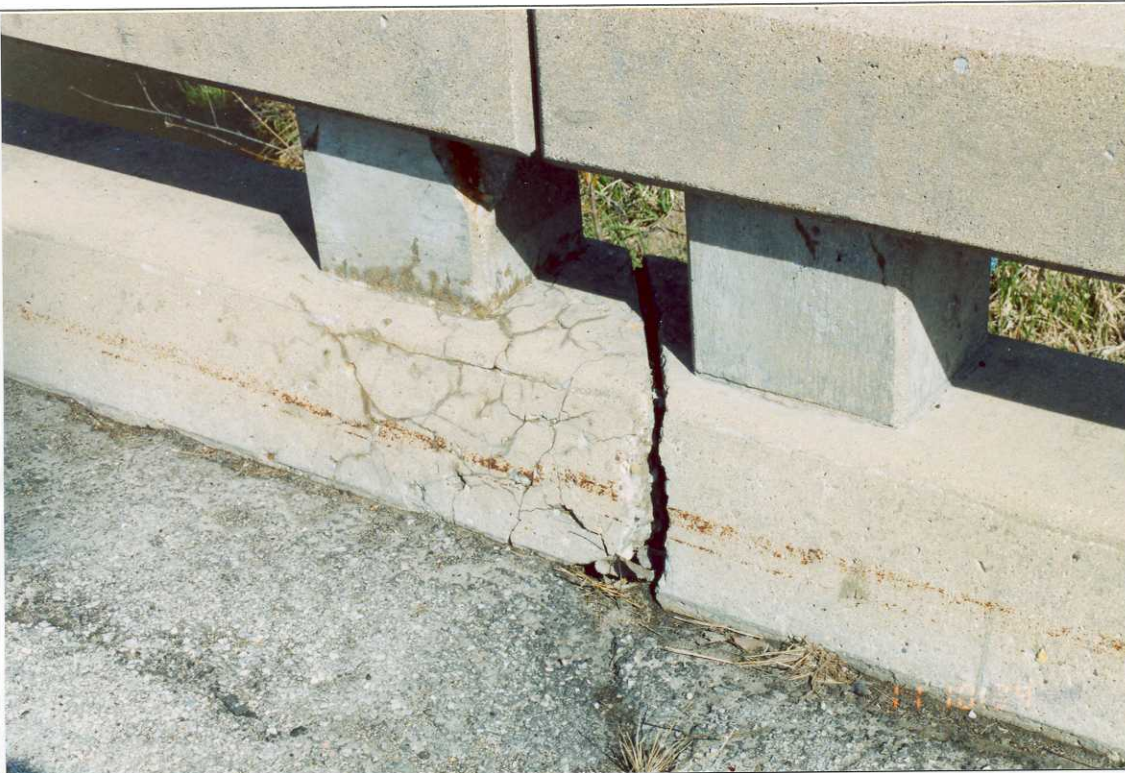
The concrete rail is in good condition. The bases of both rails have map cracking and delaminations at the pier joint and at both abutments. The remainder of the rail is in good condition.

4) Map Cracking at North Rail Center Joint, Typical Each Side

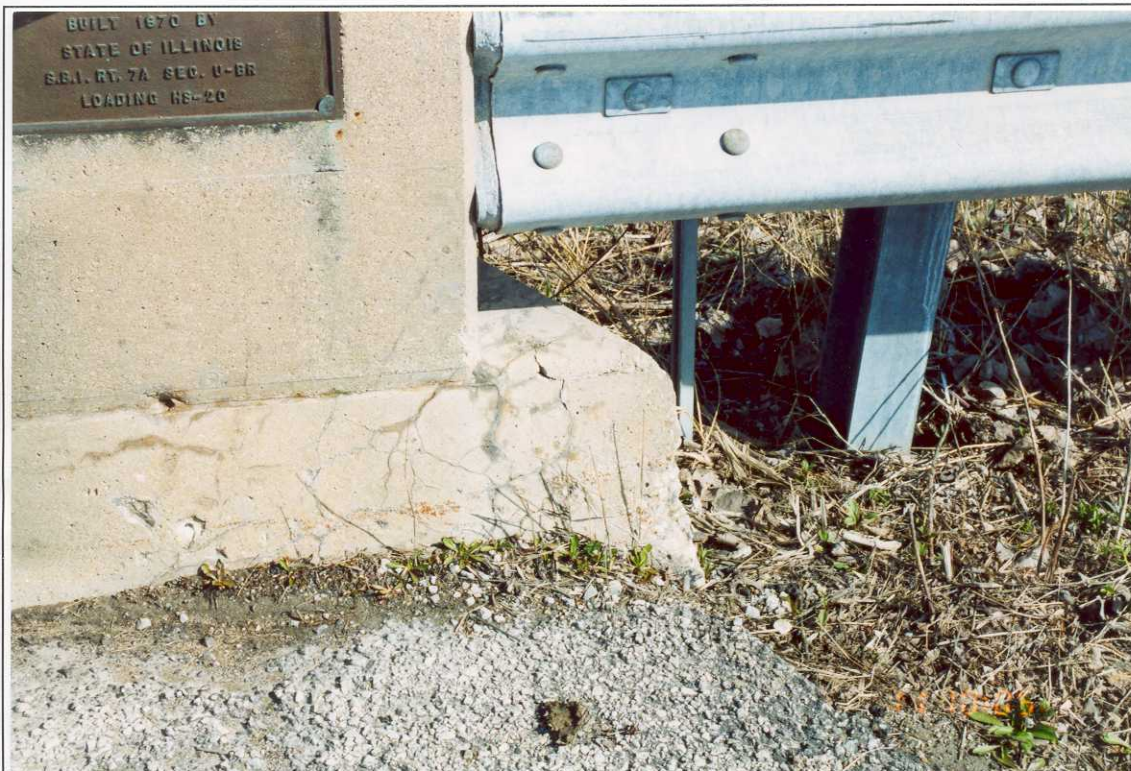
5) Map Cracking of North Rail, East End, Typical All 4 Ends

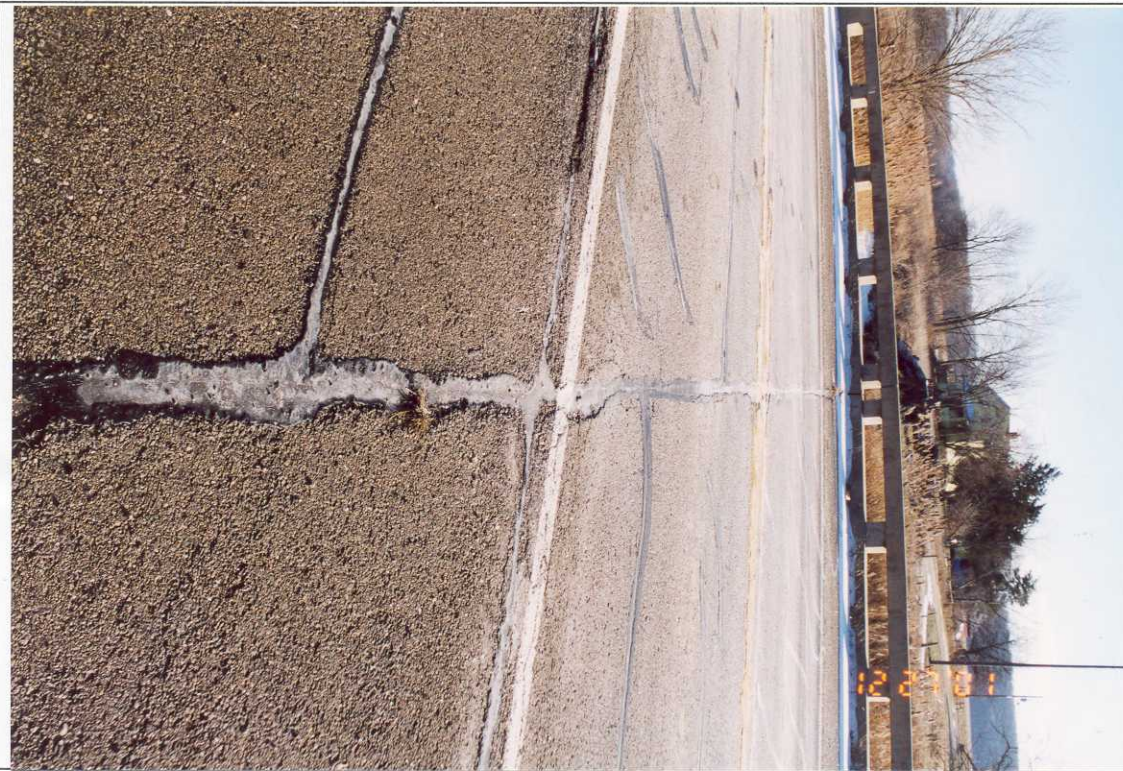
The joints are in poor condition. The joints at both abutments and the pier have been sealed with tar, but appear to have been leaking, causing some of the beam deterioration as well as the substructure concrete deterioration discussed later in this report. There is much moisture staining at both abutments and the pier.

13) Joint at Pier 1

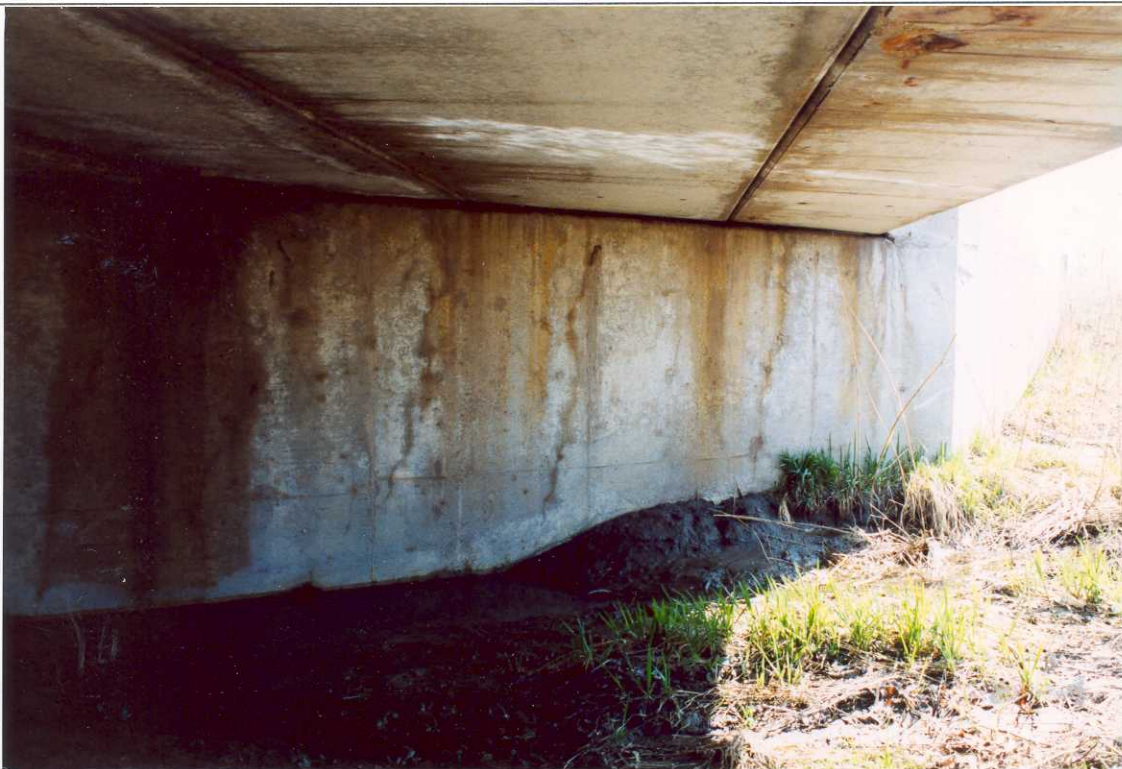
The abutments and wingwalls are in good to fair condition. There is moisture staining on the abutment seats and walls due to the leaking superstructure and keyway joints. Some minor spalls, cracks and delaminated areas are present. There are several hairline cracks on the abutment walls extending beyond the water and or ground line. The wingwalls are in good condition with little or no cracking or delaminations.

34) East Abutment, Showing Cracks and Moisture Stains

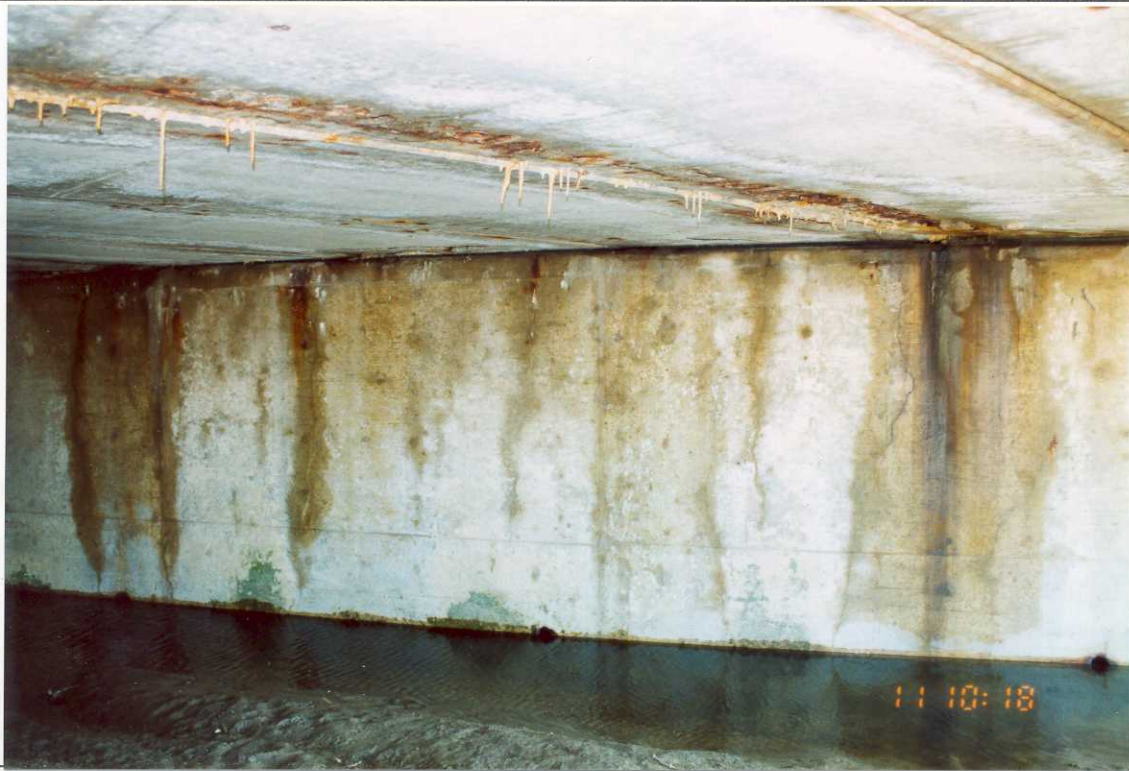
35) East Abutment Showing Cracks and Moisture Stains

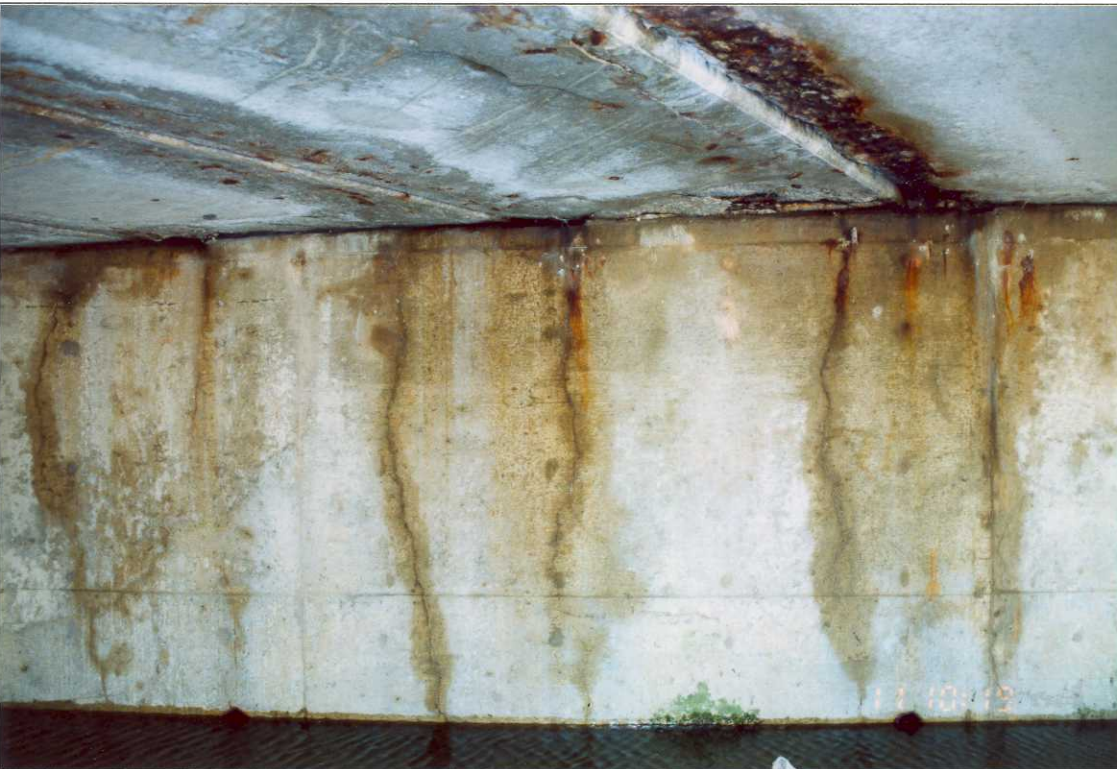
36) East Abutment Showing Cracks and Moisture Stains

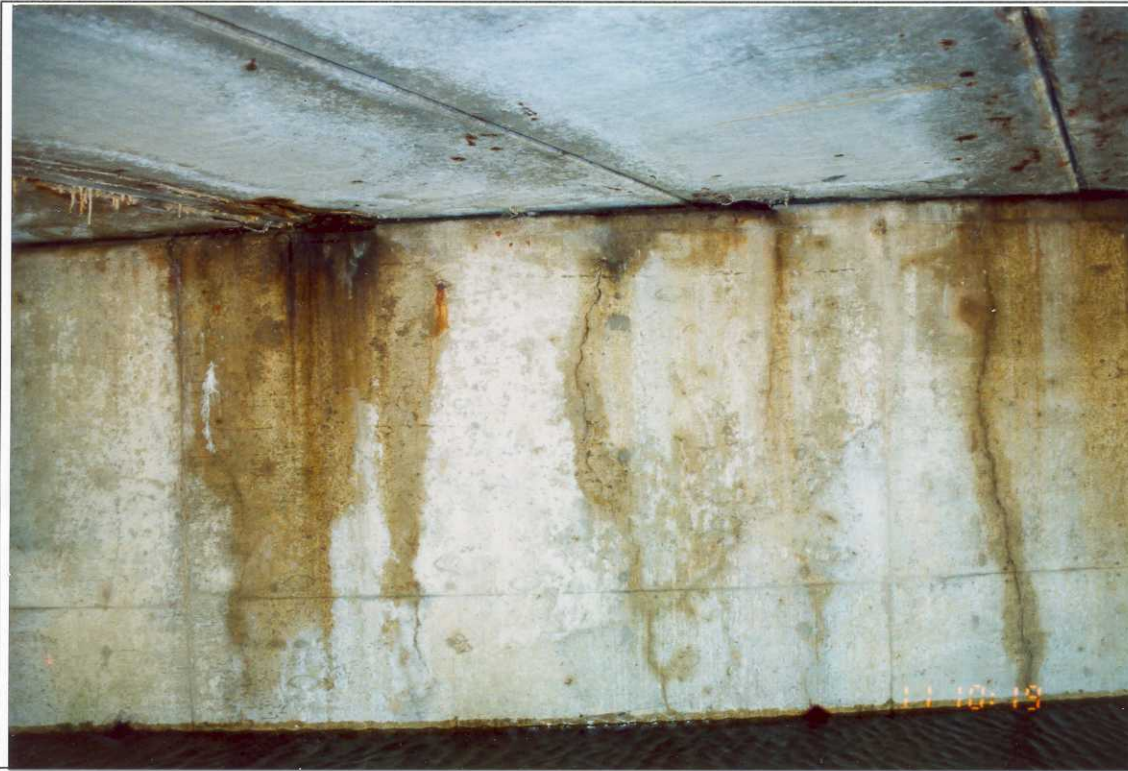
37) East Abutment Showing Cracks and Moisture Stains

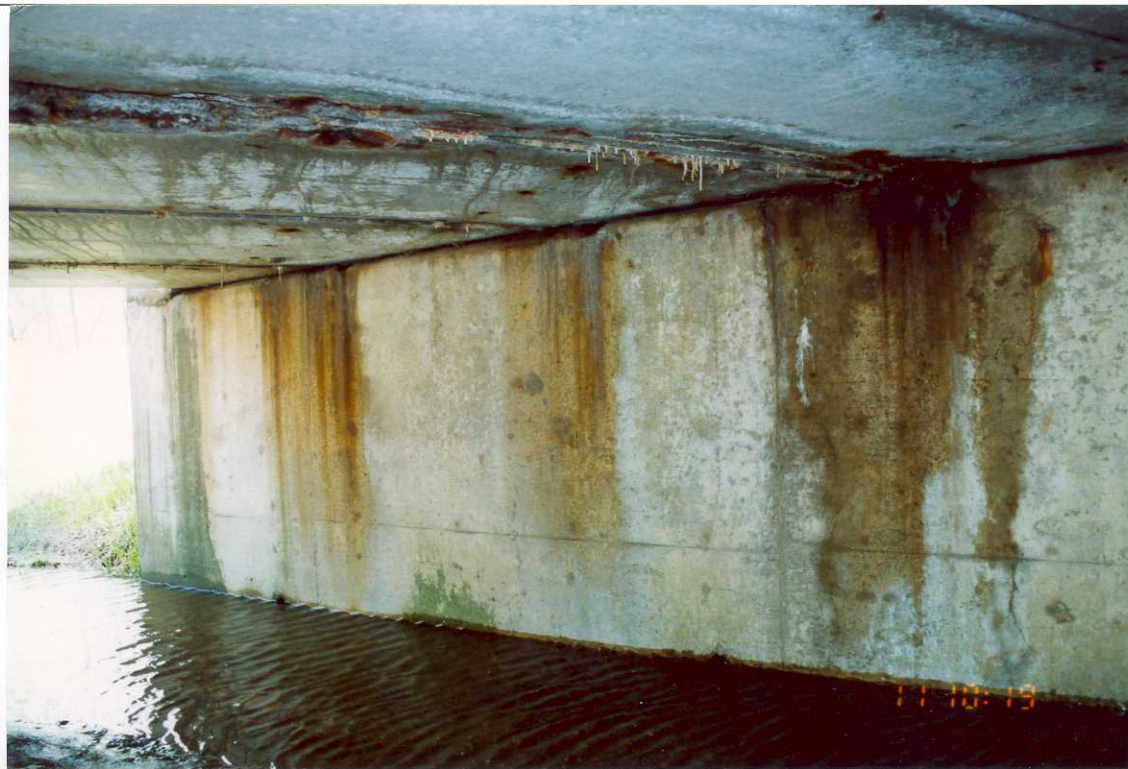
38) East Abutment Showing Cracks and Moisture Stains

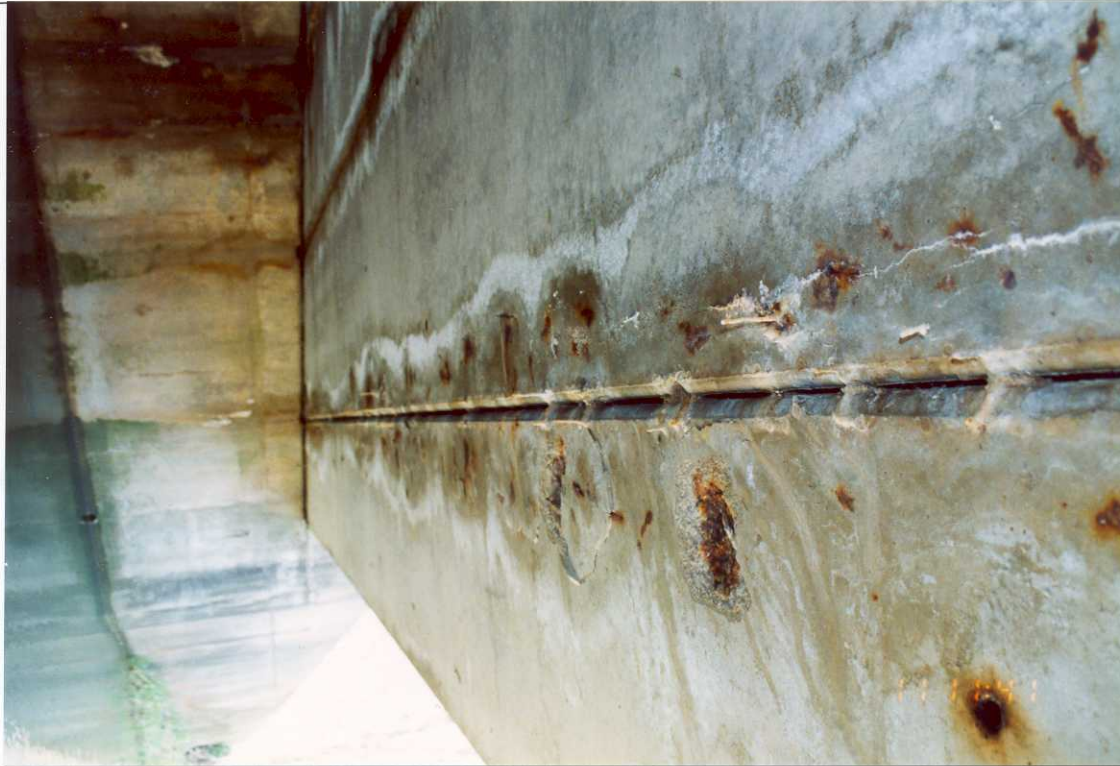
39) Delaminations, Rust, and Leaching, 1<sup>st</sup> Joint From North, Span 1

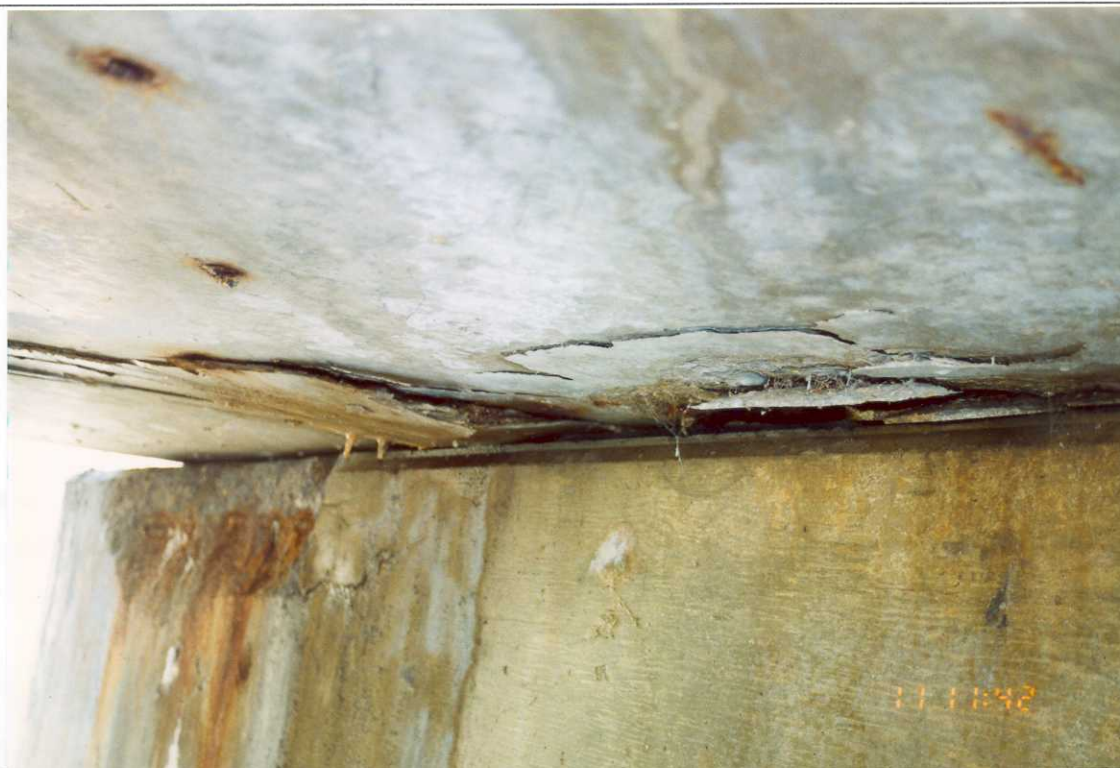
40) Spalling at Pier of 2<sup>nd</sup> Beam From North, Span 1

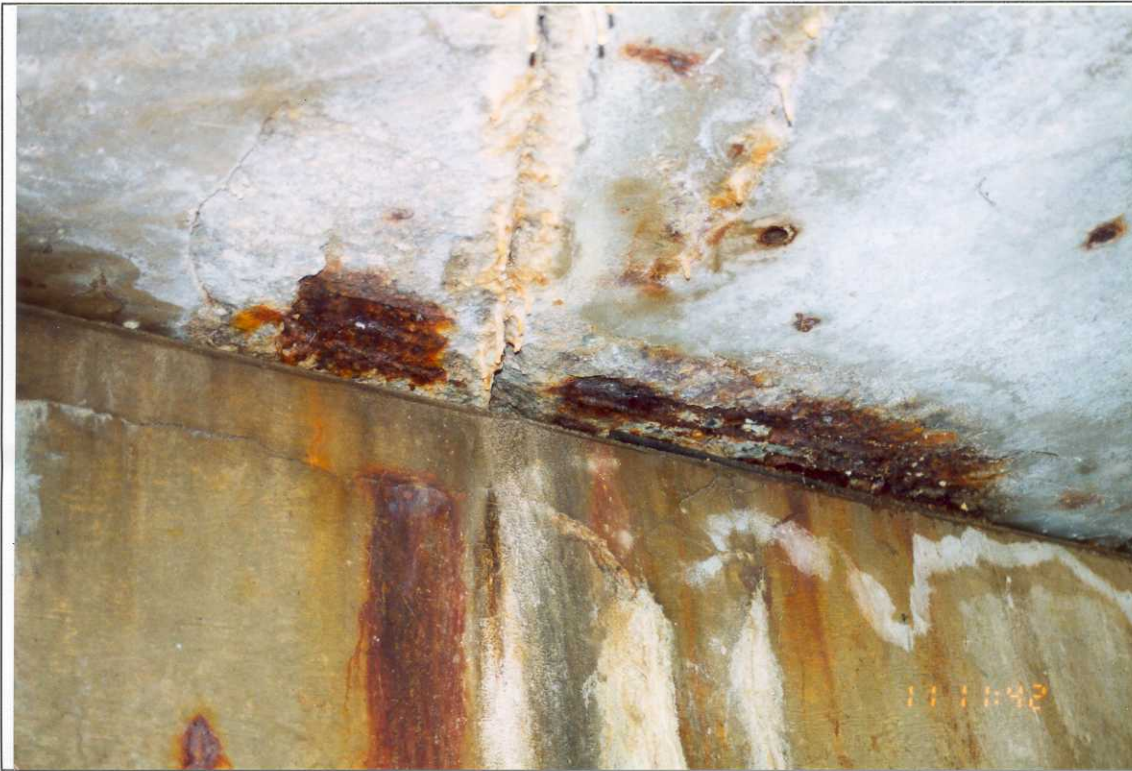
41) Spalling at Pier of 3<sup>rd</sup> and 4<sup>th</sup> Beams from North, Span 1

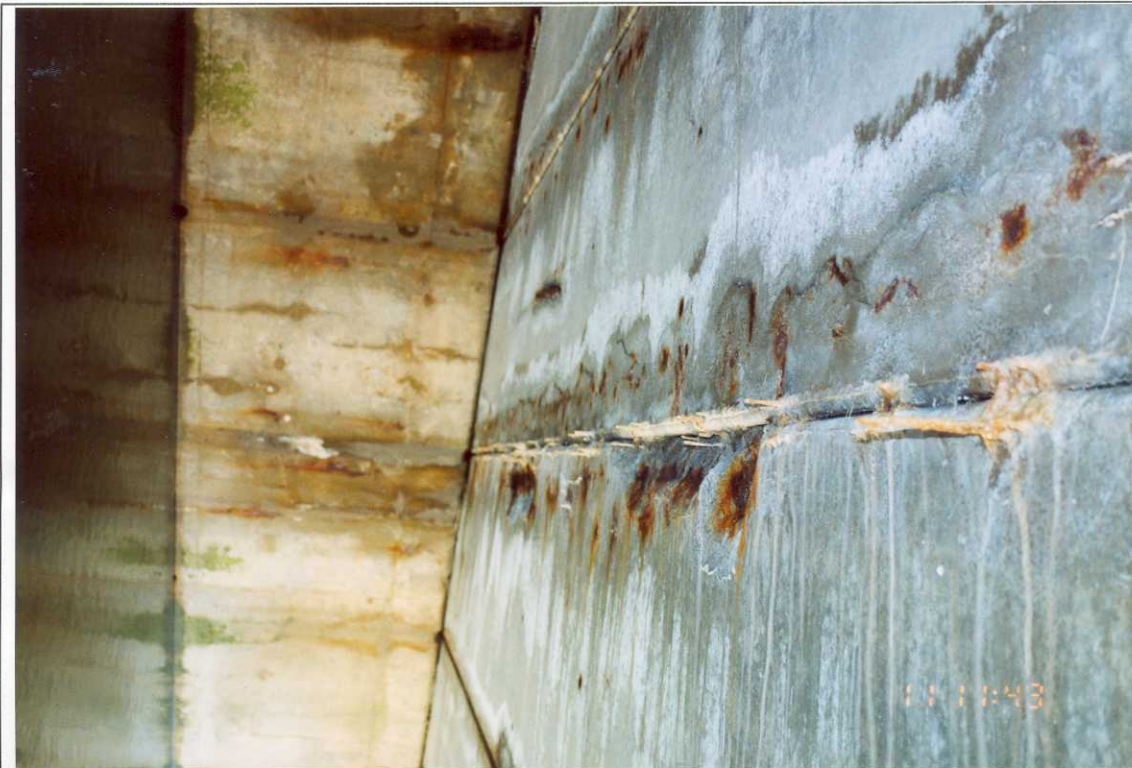
42) Spalling and Delaminations Along 3<sup>rd</sup> Joint From North, Span 1
